AIRPORT GRADE STEELGUARD

AIRPORT PAVEMENT

AGSG - AIRPORT GRADE STEELGUARD

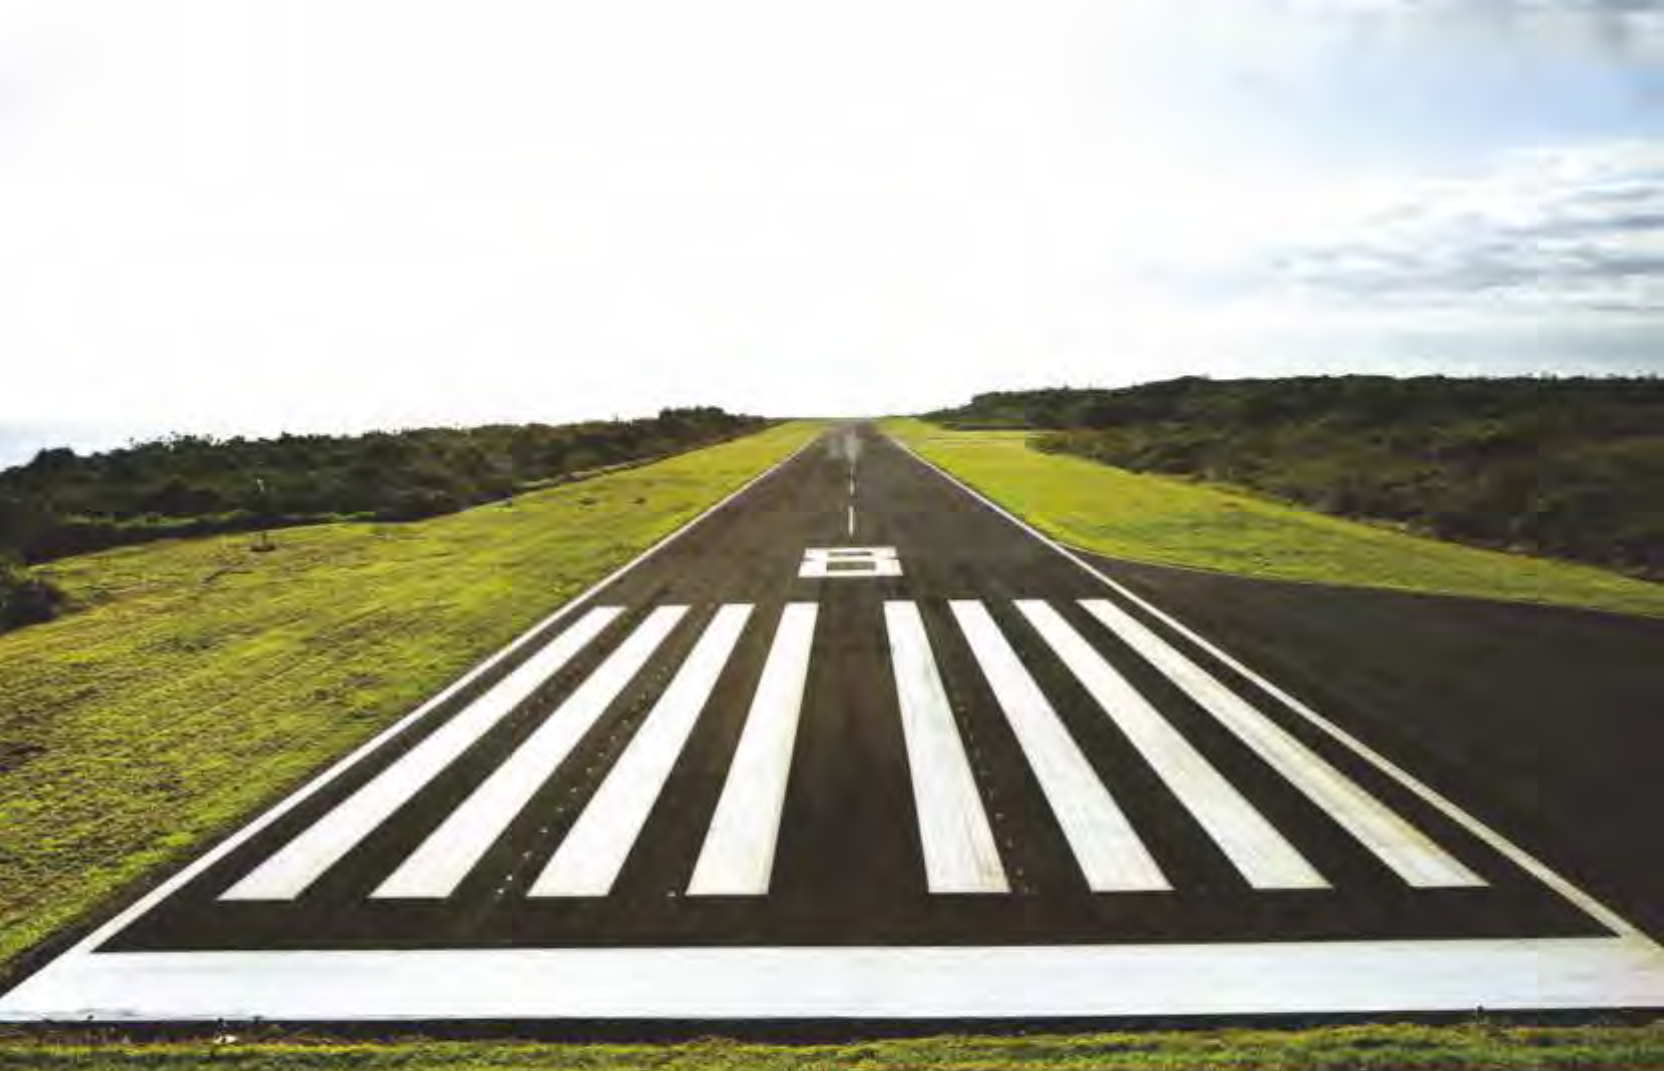
DETERIORATING SURFACE

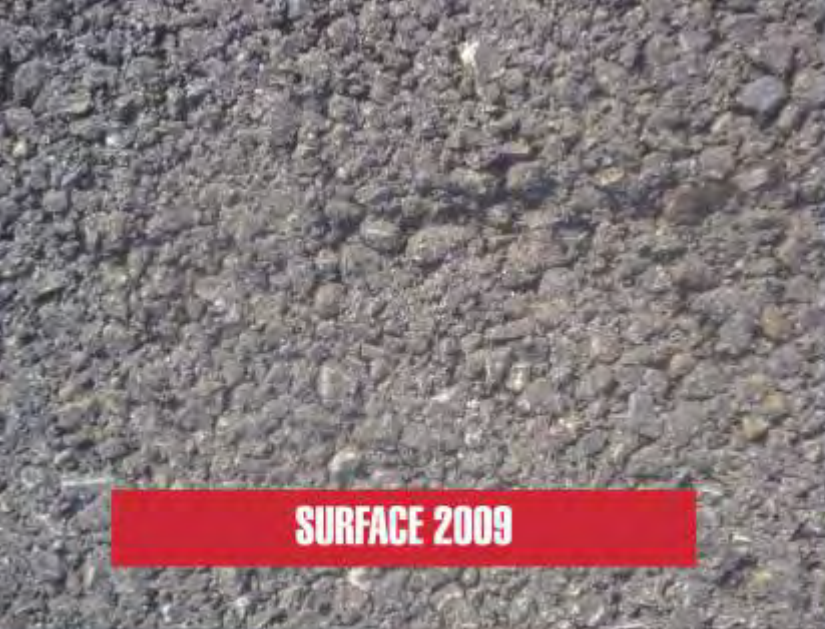
SURFACE 2009

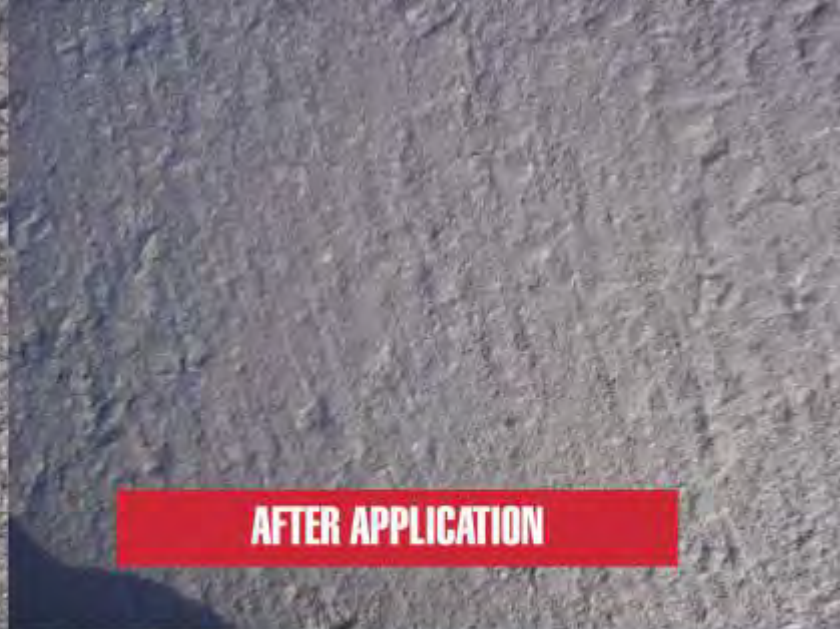
AFTER APPLICATION

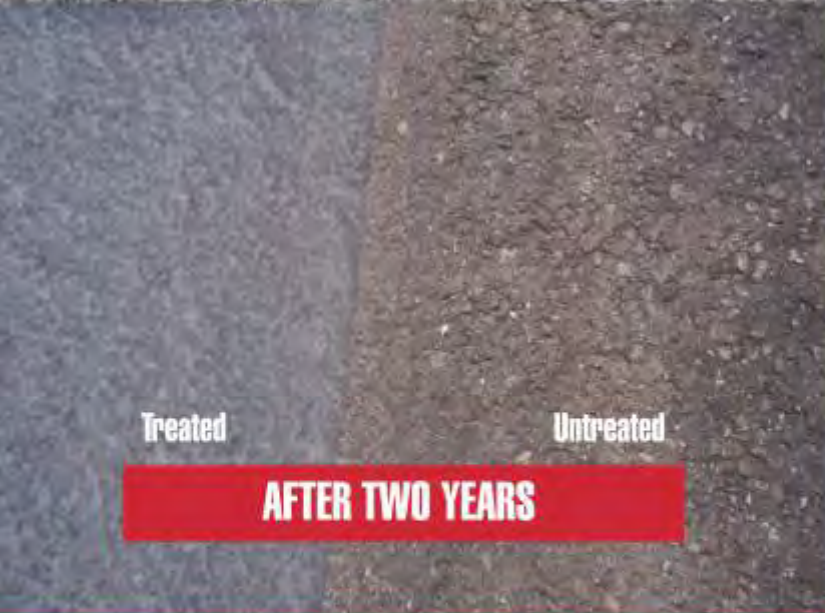
Treated

Untreated

AFTER TWO YEARS

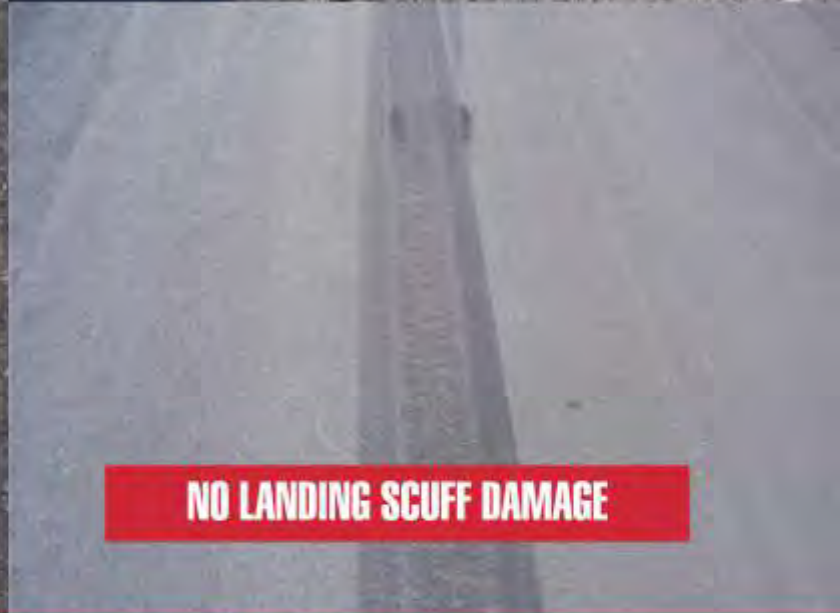
NO LANDING SCUFF DAMAGE

AGSG' technology at Santiago International Airport in Chile resulted in remarkable success! The Public Works Department recommends the product across all airports in Chile, which meant more work, more challenges, and more success!
